# VikingLink

## UK Onshore Scheme

Intertidal Zone (Proposed Underground DC Cable)

## UK Onshore Scheme Phase 1 Intertidal Survey Report

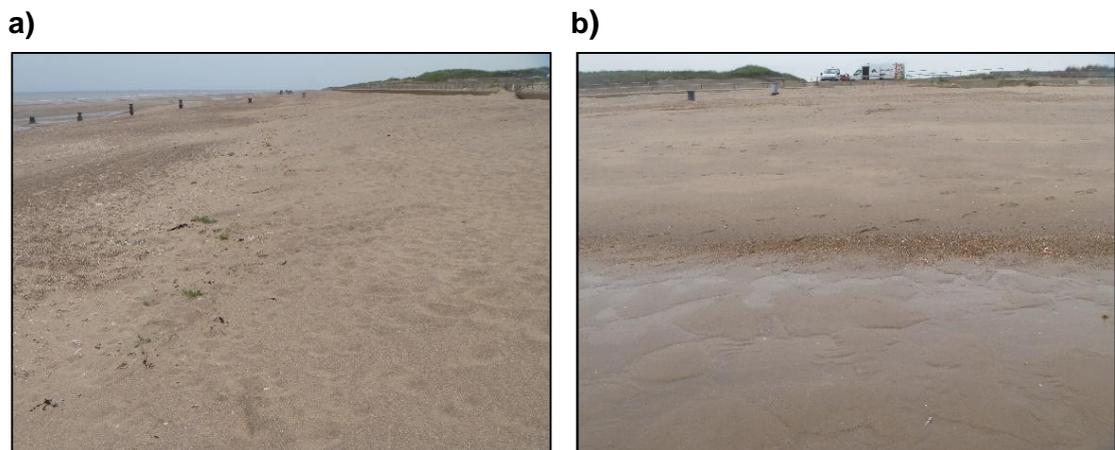
- 3.2.1 The upper beach at Boygrift landfall comprised gravelly medium to coarse dry, loose sand with no macrofauna recorded during the dig-overs, which extended approximately 40 m from the sea wall to the strandline (biotope LS.LSa.MoSa.BarSa; Figure 3.2). The strandline consisted of decomposing brown algae, razor clam shells, native oyster shells and scallop shells. A thin line of embryonic sand dune vegetation approximately 1 m wide was also present, spanning 50 m in a parallel orientation with the beach, in the northwest corner of the survey area (see Target Note 1 in Figure 3.1). A high density of sand hopper burrows (Talitrid amphipods) was present across a 2 m band just below the strandline, characteristic of the biotope ‘talitrids on the upper shore and strandline’ (LS.LSa.St.Tal) which extended the width of the survey area.

- 3.2.2 The beach elevation dropped by several metres from the strandline to approximately 25 m down shore. This feature represented the steepest gradient on the shore and extended the full width of the Boygrift landfall survey area. The sediments along the slope comprised flat, compact, drying fine to medium sands. No fauna were found in the dig-over samples and so the biotope LS.LSa.MoSa was assigned to these areas (Figure 3.1). The lower 2 m of the slope consisted of gravelly medium to coarse sand before forming a runnel parallel to the beach, maintained by water draining from the upper shore (Figure 3.2).

**Figure 3.2 a) Gravelly medium to coarse sand (LS.LSa.MoSa.BarSa); b) Runnel at base of upper shore slope (LS.LSa.MoSa.BarSa)**

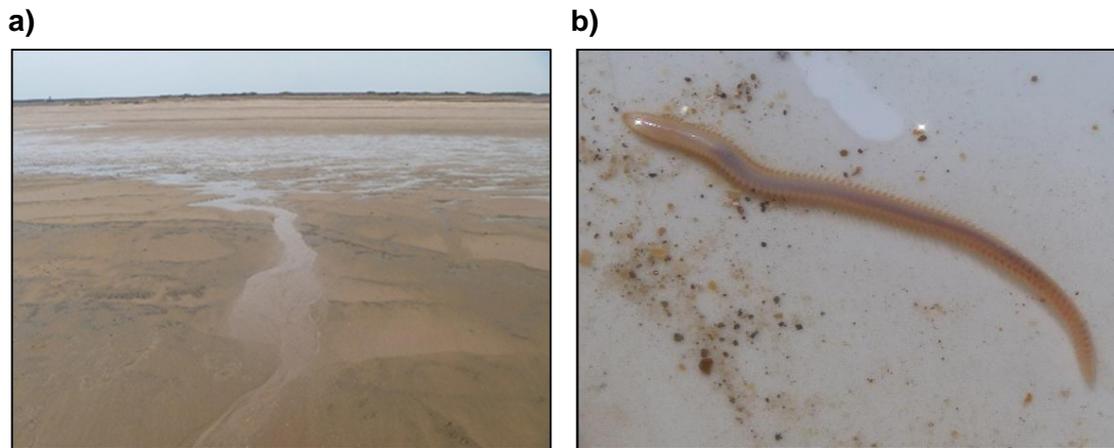
- 3.2.3 The foreshore beyond the runnel consisted of a mosaic of rippled compact fine to medium drying sand and wet rippled sand influenced by run off from the runnel (Figure 3.3). South of the outfall this area was identified as the biotope LS.LSa.MoSa and covered the upper half of the intertidal zone. No fauna were recorded in the dig-over samples in this zone. Conversely, macrofaunal invertebrates were present in the mid shore zone to the north of the outfall structure. Here the biotope LS.LSa.FiSa.Po was assigned to the habitat extending from the runnel at the base of the

upper shore slope down to the MLWS, where cat worms, *Nephtys* sp., were recorded in dig-over samples with an abundance of approximately 5 per m<sup>2</sup> (Figure 3.3).

Figure 3.3 a) Compact fine to medium sand (LS.LSa.FiSa.Po); b) a cat worm (*Nephtys* sp.)

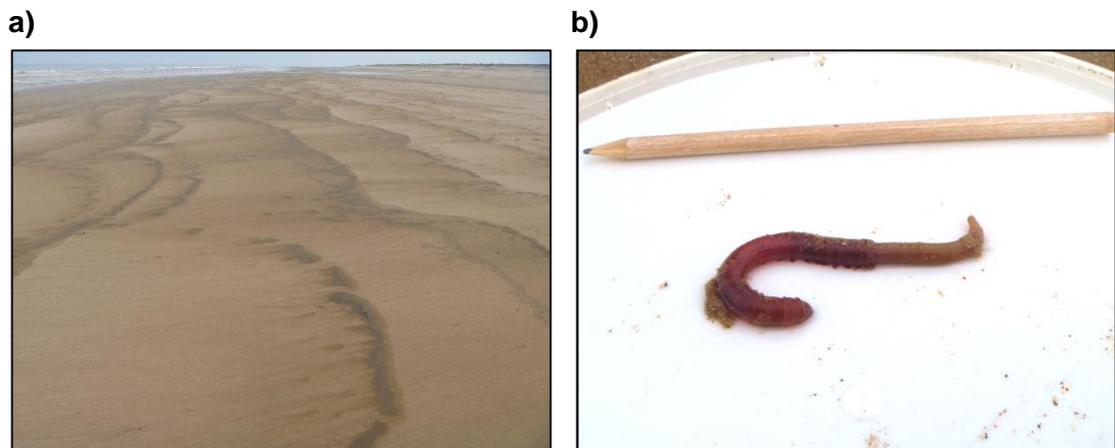
- 3.2.5 In the south of the Boygrift landfall survey area a large area (110 m<sup>2</sup>) of lug worms, *A. marina*, were also recorded at moderate densities of approximately 2.4 per m<sup>2</sup>. As with the area to the north of the outfall, sand mason worms *L. conchilega* were associated with this community, though in much lower densities (approximately 0.3 per m<sup>2</sup>). This section of the shore was considered to be a LS.LSa.MuSa.MacAre biotope variant of LS.LSa.FiSa.Po (FiSa.Po/MacAre; see Figure 3.1). With the exception of cat worms (*Nephtys* sp.), fauna was sparse in areas of the LS.LSa.FiSa.Po biotope where lug and sand mason worms were absent.

- 3.2.6 The lower foreshore across the entire site was influenced by the freshwater discharge from the Boygrift Drain fluvial outfall. The brown foamy deposits likely originated from terrestrial soil run-off (Figure 3.4).

**Figure 3.4 a) Compact fine to medium sand (LS.LSa.FiSa.Po); b) Lug worm (*Arenicola marina*).**

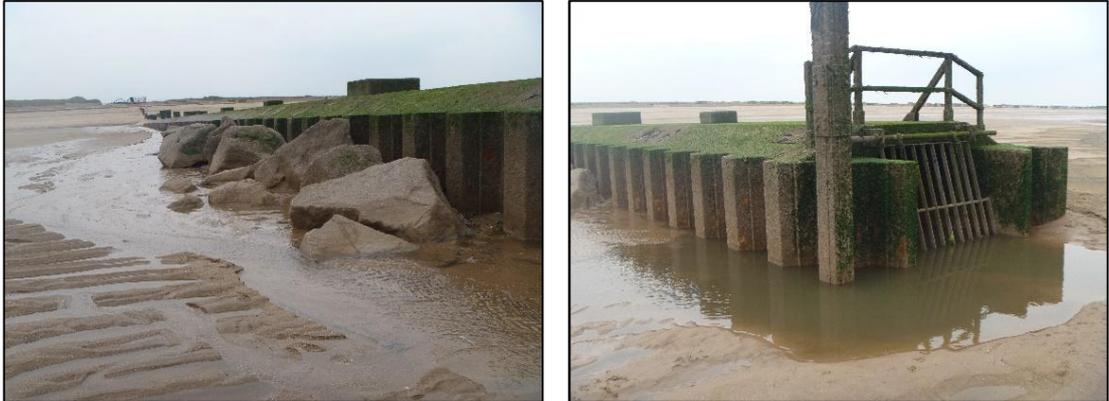
- 3.2.7 The Boygrift Drain outfall was exposed approximately 35 m from the MHWS mark and extended 120 m to the lower shore, 30 m from the MLWS (Figure 3.5). Elements of high-energy littoral rock communities were observed on the structure. Almost all of the structure and boulder surfaces exhibited 100% coverage by barnacles, representing the ‘mussel and/or barnacle communities’ biotope (LH.HLR.MusB). The same areas were also heavily covered in green gut weed, *Ulva intestinalis*. Two small aggregations of mussels were present on the outside of the outfall reflecting characteristics of the ‘*Mytilus edulis* and barnacles on very exposed eulittoral rock’ biotope (LH.HLR.MusB.MytB). Small aggregations of mussels were also seen growing deep within the inner surface of the structure. The shore crab *Carcinus maenas* was common in the immediate vicinity of the outfall and the associated boulders. Several common starfish *A. rubens* were also found in pools around the structure. A small patch of sea squirts (Ascidiacea) was observed on the vertical face at the mouth of the outfall. A small number of brown algal (*Fucus* sp.) growths were attached to the structure; these were minor and not considered to represent a fucoid-based biotope.

Figure 3.5 Photographs of the Boygrift Drain outfall

- 4.1.4 A fluvial outfall was present at Boygrift landfall, demonstrating exposed eulittoral rock communities dominated by barnacles. The shore crab, *Carcinus maenas*, and the common starfish, *Asterias rubens*, were frequently found on the sediment at the base of the structure.
